**CITY OF ROCKVILLE HISTORIC DISTRICT COMMISSION
STAFF REPORT**

**July 8, 2003
MEETING NO. 07-2003**

APPLICATION:	HDC2003-00253
DATE FILED:	June 24, 2003
APPLICANT/ OWNER:	Albert Brault and James Wilson 110 S. Washington Street Rockville, MD 20850

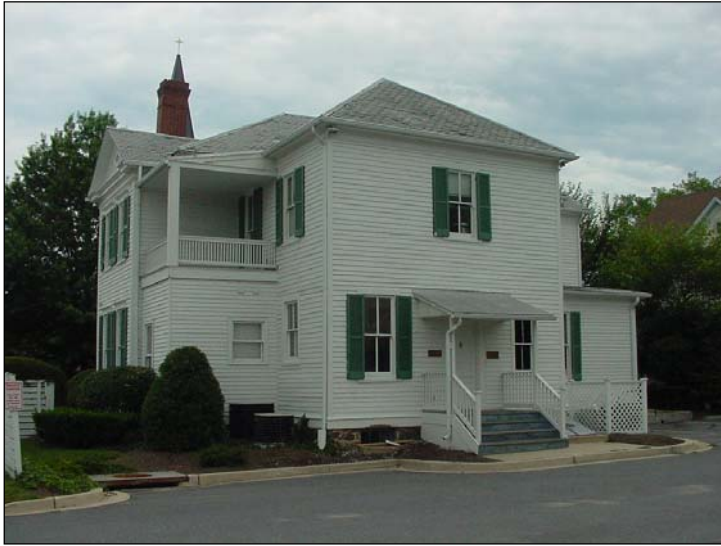
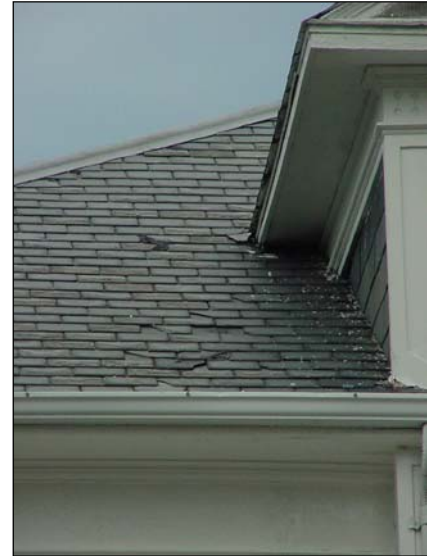
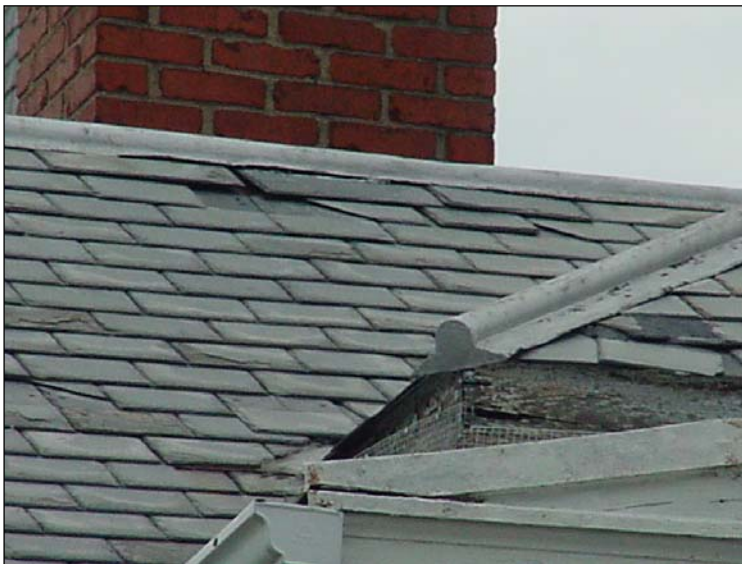
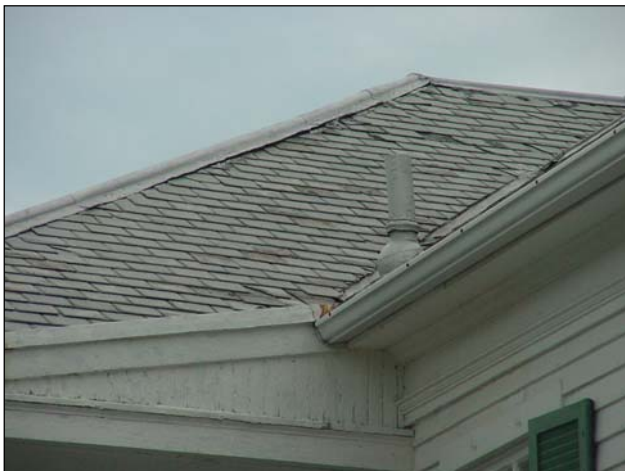
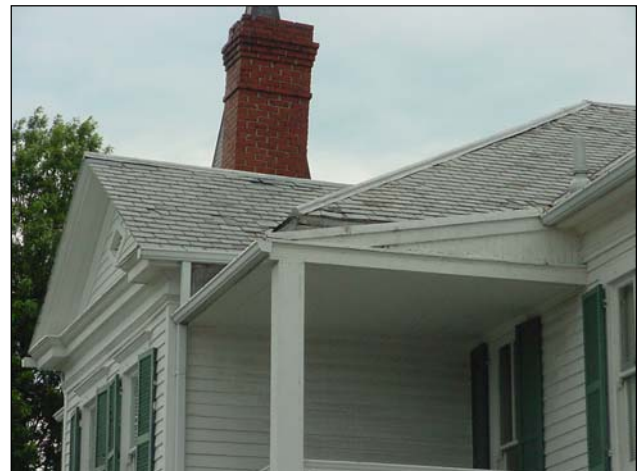
Details of current roof materials and conditions

The Linthicum House and the house at 101 S. Washington are the only two former residences that retain complete slate shingle roofs. The roof on the Linthicum House is likely the original from 1903, although parts appear to have been replaced with slate on the south and east sides. The original slate shingles are in poor condition, and exhibit delamination and cracking. Some shingles are missing.

What sets the roof at the subject property apart is its high visibility from three sides. The building is situated on a corner and a rear parking lot provides unobstructed visibility from the rear. The steeply pitched hip roof also contributes to increased visibility of roof surface. The roof has interesting caps along its ridges. These round metal caps cover the joints at roof ridges while metal flashing is located in the valleys formed at roof intersections. None of the other buildings in the district have this interesting demarcation along the roofline.

It is advisable that the source of the water infiltration be identified and that this problem be addressed. If the source is traced to damaged slate, the applicants could repair or replace with slate the shingles on just that section of the roof, as well as replace individual missing or damaged slate on the rest of the roof. If it is not possible to locate the direct source of the leak, perhaps an entire side of the complex roof could be replaced with slate rather than the entire roof and the remainder of the roof spot repaired.

Staff would like to reiterate an offer to share with the applicants a demo CD for Slate Savers, a company that repairs and retains slate roofs by injecting them with epoxy. This method would seal the roof from leaks and preserve the original materials in situ. Replacing missing shingles and ensuring adequate ventilation would likely be required if this option is pursued.

The roof ridge caps are a significant feature of this building and should be retained and re-used regardless of the roof repair or replacement material.
